**Flood Control Project Maintenance
Levee Inspections**

Maintenance Issue Types Only, Levee Inspection Report By Mile - Spring 2018

California Department of Fish and Game Shea Levee

Waterway	Bank	Unit Miles	Inspection Start/End	Inspector
Unit No. 01 Sacramento River	Left	0.30	04/20/2018 04/20/2018	Bob Duffey

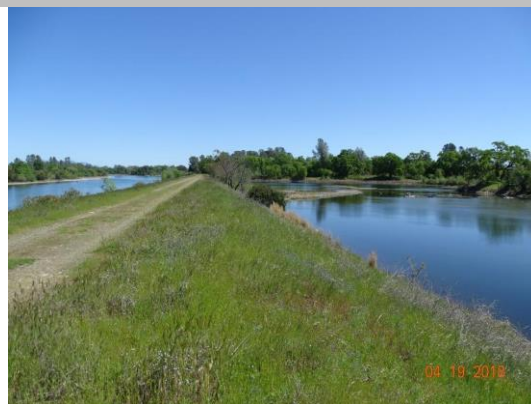
Photo 1 of 2 : SP_2018_NA0018_269_2_20180423_00005.jpg

LM Start	0.00	Rating **	M	Issue No.	2
LM End	0.30	Issue Type +	Ma	Location *	LS
Category	Earthen Levee			GPS Latitude/Longitude	
				Start	End
Item	Vegetation			40.507697 °	40.511210 °
				-122.363683 °	-122.360390 °
DWR ID	DWR_NA0018_01_s_2012_2				
Comment Code					
V2 : Remove the wild growth other than native grasses from the levee slopes.					
Inspector Comment					
California Department of Fish and Wildlife has not completed any maintenance this year.

View of the vegetation along the landside slope.

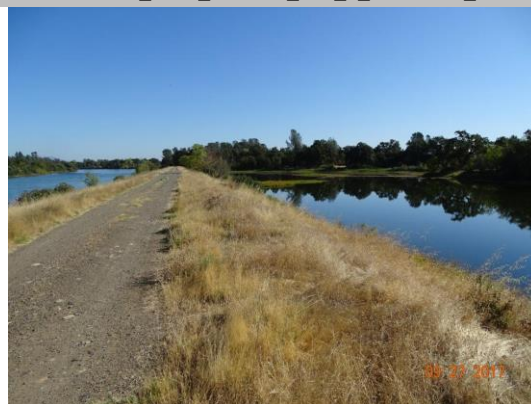
Photo 2 of 2 : SP_2018_NA0018_269_2_20180305_00002.jpg

LM Start	0.00	Rating **	M	Issue No.	2 (cont)
LM End	0.30	Issue Type +	Ma	Location *	LS

View of the vegetation along the landside slope.

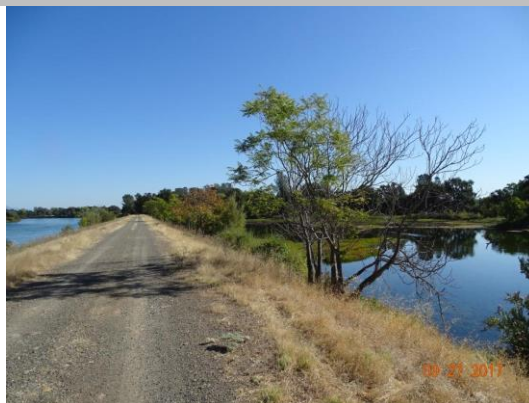
Photo 1 of 1 : SP_2018_NA0018_269_3_20180305_00004.jpg

LM Start	0.00	Rating **	M	Issue No.	3
LM End	0.30	Issue Type +	Ma	Location *	LS
Category	Earthen Levee			GPS Latitude/Longitude	
				Start	End
Item	Trim / Thin Trees			40.507738 °	40.511210 °
				-122.363682 °	-122.360390 °
DWR ID	DWR_NA0018_01_f_2017_3				
Comment Code					
T3 : Trim and thin trees to allow visibility of the ground and room to flood fight.					
Inspector Comment					
Trim and remove trees to allow visibility.

View of the trees along the landside slope.

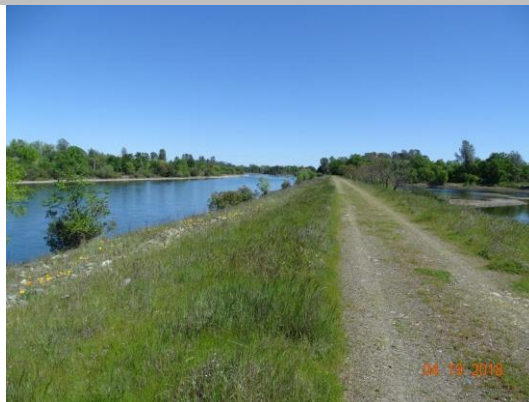
Photo 1 of 2 : SP_2018_NA0018_269_1_20180423_00006.jpg

LM Start	0.00	Rating **	M	Issue No.	1
LM End	0.30	Issue Type +	Ma	Location *	WS
Category	Earthen Levee			GPS Latitude/Longitude	
				Start	End
Item	Vegetation			40.507697 °	40.510670 °
				-122.363683 °	-122.361203 °
DWR ID	DWR_NA0018_01_s_2012_1				
Comment Code					
V2 : Remove the wild growth other than native grasses from the levee slopes.					
Inspector Comment					
Remove the vegetation from the waterside slope.

View of the vegetation along the waterside slope.

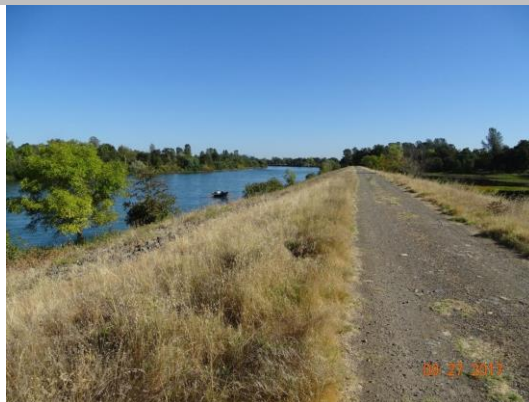
Photo 2 of 2 : SP_2018_NA0018_269_1_20180305_00001.jpg

LM Start	0.00	Rating **	M	Issue No.	1 (cont)
LM End	0.30	Issue Type +	Ma	Location *	WS

View of the vegetation along the waterside slope.
